The Documentation of Rural Wooden Minarets in Akseki- Manavgat- İbradi Regions of Antalya and Determination of Their Construction Systems

Özlem SAĞIROĞLU^{1,}

ABSTRACT

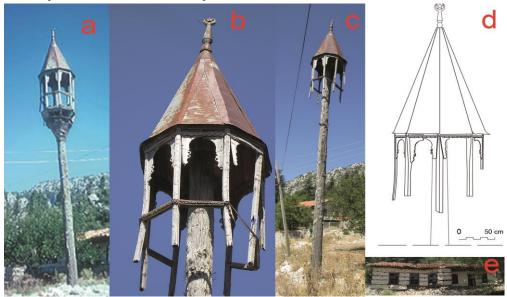
Minaret is 8.9 meters in height up to the spire and only the end ornament, spire and a part of minaret balcony have reached today. In the photo of the minaret in 2010, it is seen that minaret balcony and the bottom of it seem to be present. [9] (Fig.3a). But, when it was reached to the village for the study in 2015, it was seen that minaret balcony and the bottom of it had been completely destroyed. There is no information or trace about the direction or starting point of the stairs of the minaret. Due to the fact that the traces about the madrasah have been vanished, the minarets direction or position according to the madrasah is not known either. In the section where minaret balcony is combined with the spire, there are arch shaped, engraved and elegant timber panels 'yaşmak'. Since there are serious cracks and separations on the boom pole, there is a possibility of the minaret being collapsed if it is not repaired immediately.

Figure 3. Old photo of Mecidiye Madrasah Minaret in Güzelsu village (a) [9], Photographs of minaret taken in 2015 (b,c), measured drawing of minaret - elevation(d) and photograph of old Koran course taken in 2015 (e).

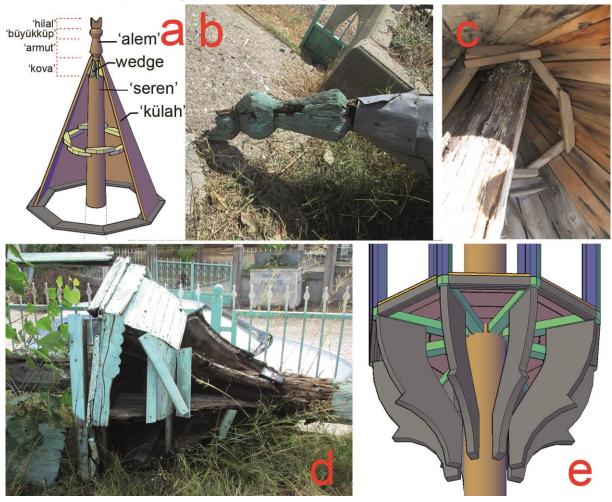
The timber cover boards forms the sides of the octagon spire by tampering, starting from the 15-20 cm to the top of the end ornament's 'kova' section. The number of timber covers used in each edge is originally 3. But with the repairs in time, the number of timber on some edges and the width changed. In these repairs, pine was preferred instead of cedar that was used for the original parts. (Fig.9c)

Figure 9. 3D model (a,e) and photographs of Yaylaalan old mosque minaret taken in 2015 (b,c,d)

These timber cover boards which forms the octagonal spire are fixed to the end ornament by the wedges, to the spire's stringer by nails and to each other by wedges at the middle of the spire (Fig.9a,c; Fig.10a). There is a zinc plate cover on the timber cover boards that formed

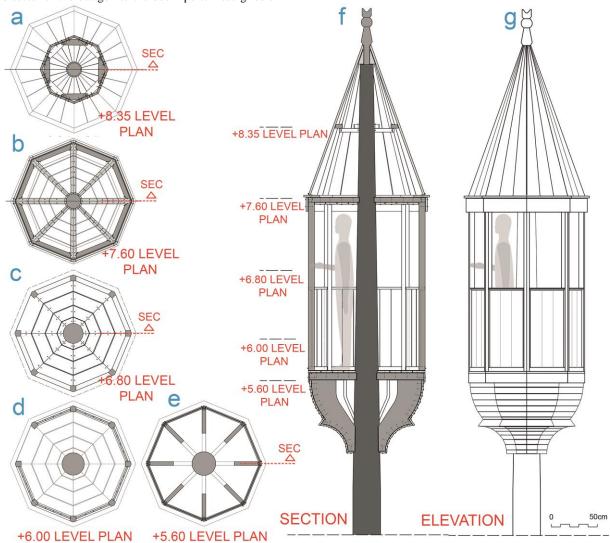
Figure 10.The measured drawing of Yaylaalan old mosque minaret

formed by the timbers of 10x85x2 in size. The bottom of the minaret balcony is enclosed with timber cover boards identical with the ceiling. It is seen that during the repairs made in time, the floor of the minaret is coated with zinc sheet, on top of the cover boards as in the spire (Fig10.d).
