The Documentation of Rural Wooden Minarets in Akseki- Manavgat- İbradi Regions of Antalya and Determination of Their Construction Systems

Özlem SAĞIROĞLU^{1,}

ABSTRACT

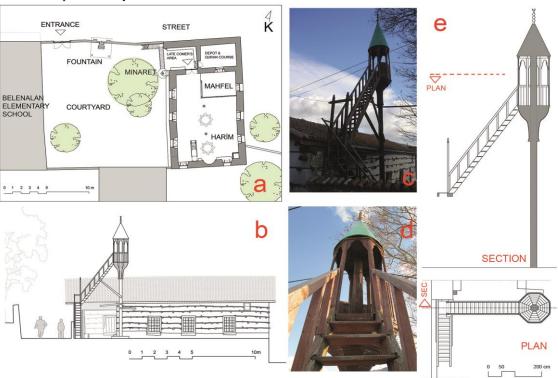
Figure 2. The measured drawing (a,b,e) and photographs (c,d) of Belenalan old mosque [8].

Climbing to the minaret where a single monolithic cedar trunk is used as a boom pole, that is 1015 cm in height, is provided with L-shaped staircase starting adjacent to the courtyard wall. Minaret ladder was constructed with the method of fitting the dovetailed steps 'basak' between two notch boards (Fig.2d). The size of the steps are 21 x 41 cm and it is in a width to allow only one person to pass. After the first 12 steps, it is reached to a platform at +2.93 level. The platform is 29x54 cm in size and it is fitted on notch boards from one side and timber girders extended out of load bearing

walls of the mosque on the other side. After the platform, a wooden arch was designed at the beginning of the stairs ongoing to the minaret balcony. It is accessed to the minaret balcony with 18 steps after this arch. There is a timber guard rail that is 72 cm in height ,constructed on notch boards, on both sides of the stairs (Fig.2b,c,d,e).

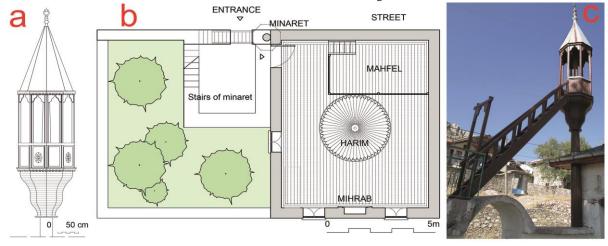
Climbing to the minaret of the mosque with wooden minaret in Çimi is made with L-shaped stairs fitted opposite the 'Harim' door (Fig.4b,c). The first flight of stairs, rising from the courtyard is reinforced concrete and it was made again in the same dimensionsinstead of

the existing stone stair, during repair [10]. The original timber part of the stairs starts over courtyard walls. There is a wooden arch at the starting point like Belenalan old mosque as a typology for these wooden minarets. Wooden part of the stairs has been manufactured with fitting the joint stepsbetween the notch boards as in the other minarets stairs. Steps are 45 cm in width. There is a wooden guard rail that isaround 70 cm in length on the notch board.

Figure 4.The measured drawing of mosque with wooden minaret and minaret in Çimi village (a,b), and photograph taken in 2015 (c)

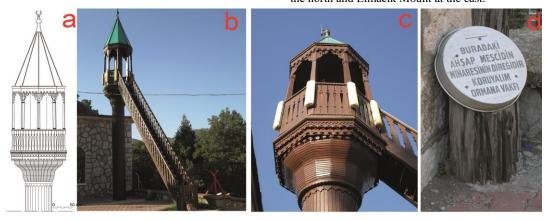
Figure 5. The measured drawing of minaret (a), Current photos of the Minaret taken in 2015 (b,c,d)

Since a part of boom pole of the original minaret is protected by Ormana Foundation, the place of original minaret is known (Fig.5d). The existing minaret today has been built right next to the old minaret. The boom poleof the original minaret is uncoated like in other

existing minarets. In the minaret that is existing today, the boom pole is surrounded by cover boards. Since the boom pole coated with wood cover boards takes up more space than the normal, the octagonal minaret balcony has been made wider than the other minarets. Since it was built in the near past, there is not any deterioration. The woodworking of the minaret built in accordance with the original construction techniques is meticulous (Fig.5c). It is used for touristic purposes todayand is not functional.

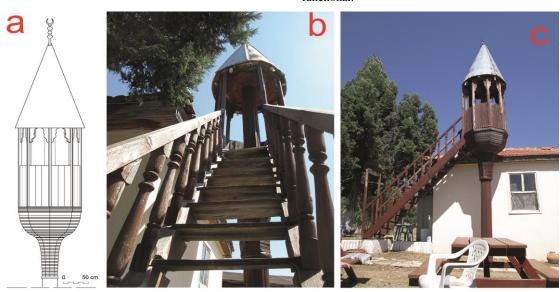
Figure 6. The measured drawing of the minaret - elevation (a), Current photos (b,c)

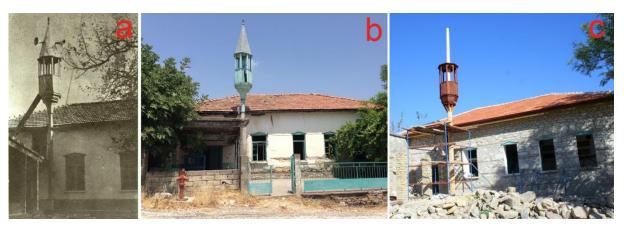
Figure 7. Yaylaalan village old mosque; unknown date(a)[15], July2014(b), October 2015(c).

Minaret is approximately 9.65 m. It is understood from the old photos that it is made with a timber staircase located along southwestern body wall.(Fig.7a). Neither the original of the photograph is found, nor the information about date when it is taken can be learned. For this reason, the destruction date of the staircase is unknown.
