## The Typological Analysis of Alanya Rural Houses; In Terms of Architectural Elements

### Abstract

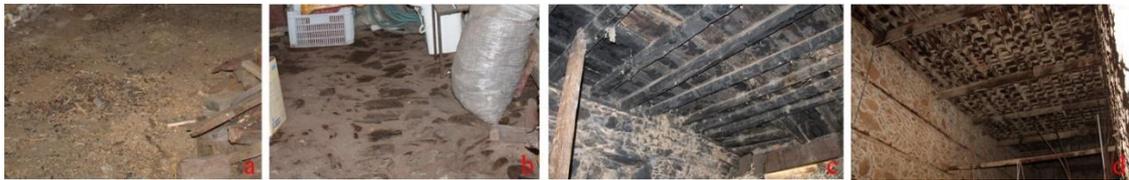
**Figure 2.** The flooring system of traditional houses in Alanya's rural region ((packed soil flooring (a), slate stone pavement (b), single timber cross-girder flooring system (c), and double timber cross-girder flooring system (d))

In the buildings, it was found that the ground floor was formed in 2 ways. The first of these is based on leaving and compressing the soil in its natural state (Figure 2a), while the other is obtained by placing the slate stones with spaces (Figure 2b). The size of the stones varies between 5 cm and 80 cm, and they are obtained from the immediate environment. The laying of the first floors of the buildings was formed by covering the boast wooden beams with a diameter of 12-28 cm with wooden veneer boards (Figure 2c). The distance between the beams varies between 30-80 cm. From time to time, it is also seen that these floors are supported by wooden poles. In more qualified dwellings, the use of cladding boards on double rows of wooden beams is seen (Figure 2d). In this type of flooring, the beams in the upper row were spaced and thinner.

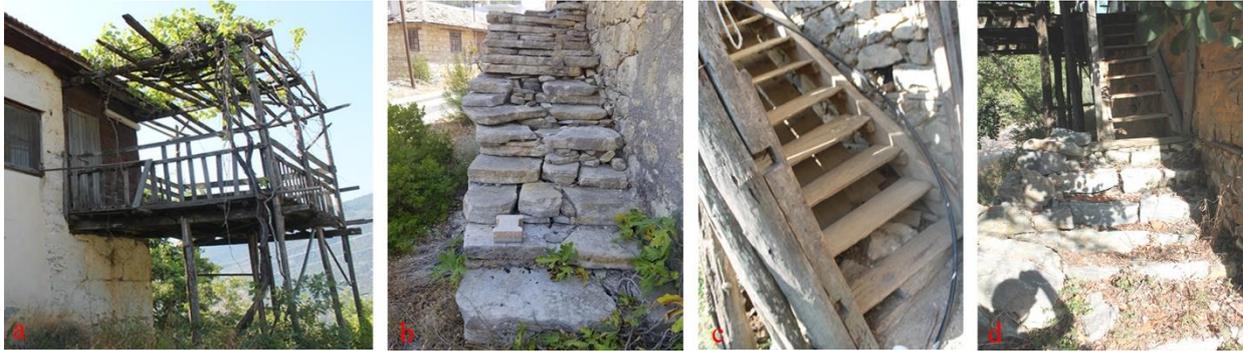
**Figure 3.** Example of cantilever (a) and types of stair (stone stair (b), wooden stair (c), mixed material stair (d)) of traditional houses in Alanya's rural region

The cantilevers in Alanya has diversified as corbels, open cantilever (gazebo), and closed cantilever (çağnışır) in qualified residences. The cantilevers are wooden with unique patterns, and the use of reinforced concrete or metal materials is seen in the replaced examples (Figure 3a).

In the survey in the area, it was found that they provide access to the upper floor from outside the structure in the villages of Türkteş, Mahmutseydi, Dereköy, Seki, Dimalacami, Beyreli, Bayırkozağacı, Karamanlar and Kayabaşı, and in other villages they were found to be located inside the structure. Due to the topography, there are also structures without stairs that provide access from different elevations. As part of the study, it was found that the stairs form two different types according to their position, and three different types according to their material. These types include stone stairs (Figure 3b), wooden stairs (Figure 3c), and mixed material stairs with 4-5 steps in stone and the upper part in wood (Figure 3d). Of the stairs, 95% is single-arm stairs, while 5% is of the "L" ladder-type and there is no use of stone stairs in the houses.

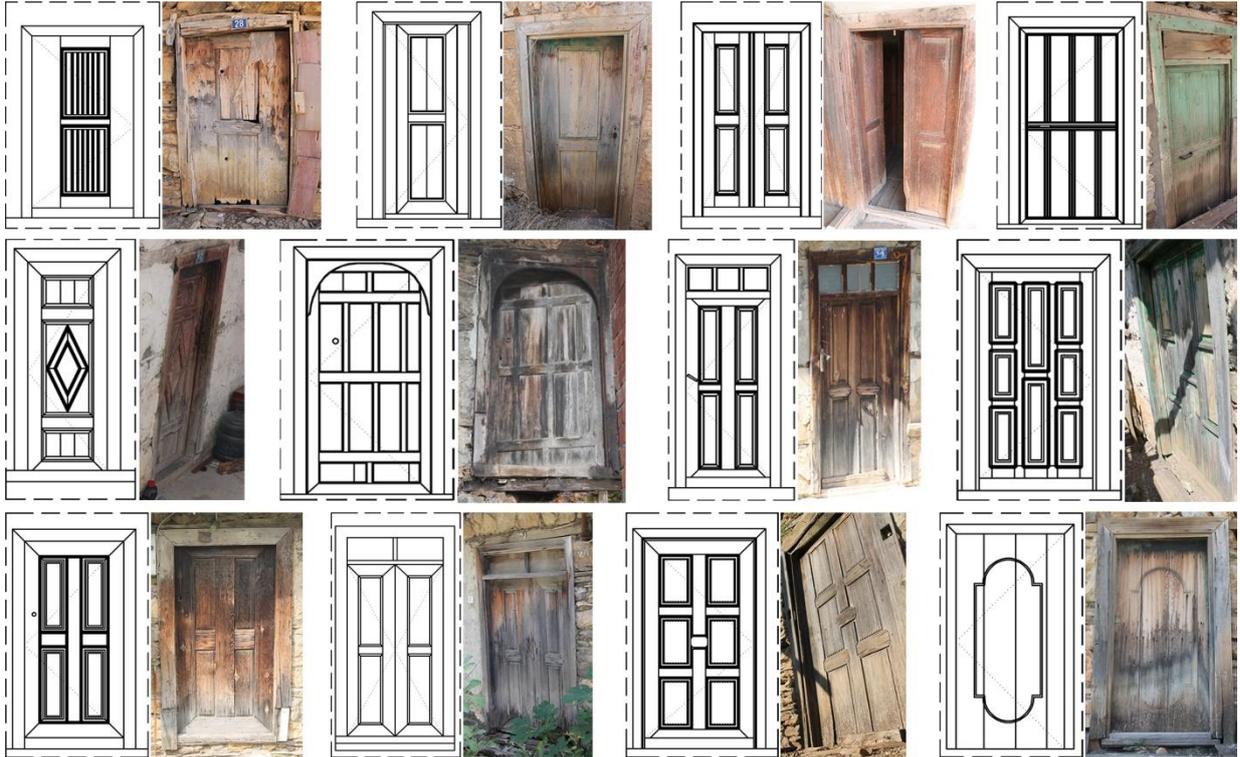
**Figure 5.** Types of exterior doors of traditional houses in Alanya's rural region

Of the residences in rural area, the exterior doors are single (92.2%) or double-winged (7.8%). However, both types are seen in 2 houses with more than one entrance. The thickness of the wood in the entrance doors is in the range of 4-6 cm, the width of the door wings ranges between 80 and 110 cm in single-winged ones, and between 65 and 90 cm in double-winged ones. The height of the door wings was measured between 180 and 220 cm. Most of the exterior doors in the area are designed in paneled form. A batten door is rarely seen and accounts for 2% in the area. Paneled doors are simple and have different belt layouts. Geometric or plant motif decoration is not used on the entrance doors of the dwellings. Since an arched formation does not exist in this region in any way, all the door gaps are formed with wooden lintels in all villages. It is worth noting that only one residential entrance door has a veil panel (Figure 5).

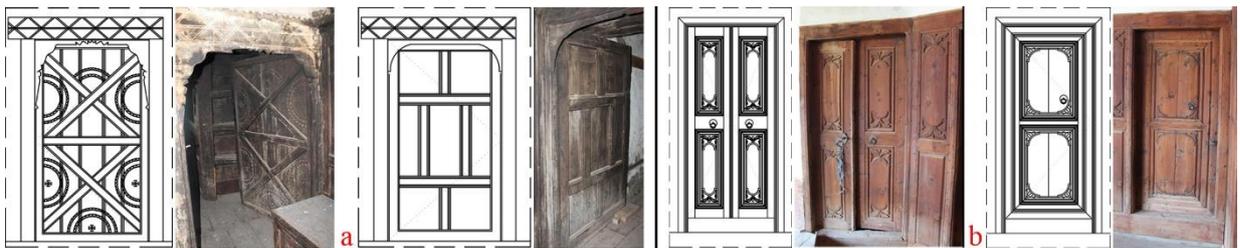
**Figure 6.** Types of interior doors of traditional houses in Alanya's rural region ((a) boarded interior doors (a) and floral ornamented interior doors (b))

The interior doors of the houses in the Alanya countryside were made more elaborately. However, since they are rural housing, the decoration and motif are not very prominent. The use of double-wing doors outside the village of Türktaş is not seen in the interior doors. In Türktaş, double-wing doors are used in 2 large mansions. The internal door wings are 4-6 cm thick, 80-110 cm wide, and 170-220 cm high. Looking at all the structures in the countryside, panel and veil panel formations are seen on the doors only in 2 of the houses (Figure 6a). Veil panels are 4 cm thick on both doors. No material other than wood was used in the doors. Plant motifs are seen in 2 doors, one of which is a single wing and the other is a double-wing door (Figure 6b).

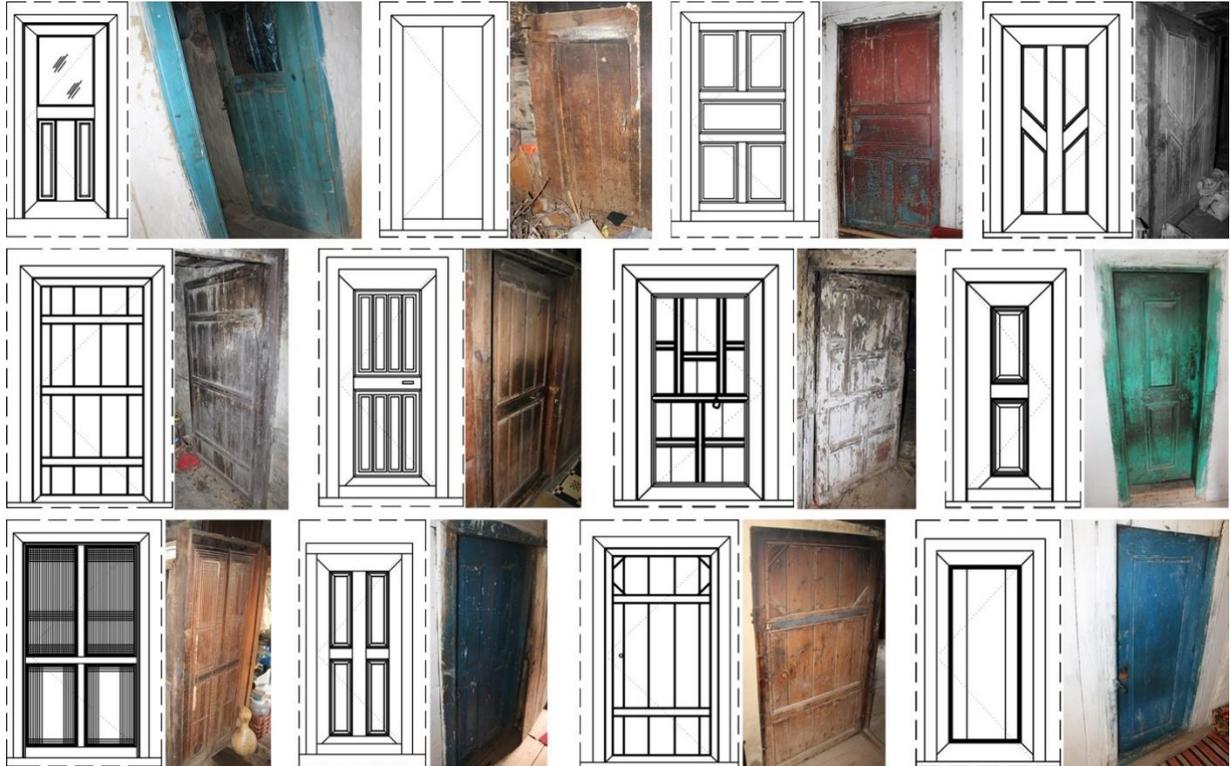
Figure 7. Types of simple panel doors of traditional houses in Alanya's rural region

In the qualified residences in Alanya rural area, simple paneled doors were mostly used. In simple paneled doors, the number of compartments varies between 2-10. The belts separating the panels are both horizontal and vertical and their width ranges from 3 to 8 cm. Motifs and shapes were created by processing and carving on the upper panel on the doors, but the decoration was also made directly carving the lower panel. Although the doors are mostly used in plain form, they are also used by painting in different colors (Figure 7).

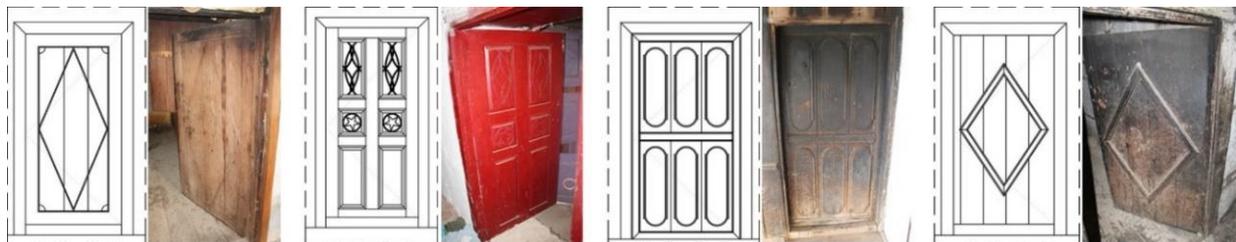
Figure 8. Types of geometric ornamented doors of traditional houses in Alanya's rural region

A small number of geometric decorations are also visible on the doors. Geometric decorations were carved or made with batten in a relief form. Two geometric elements were used as motifs in the decoration. The first of these is the rhombus. Another motif consists of rectangles terminated with a circle or semicircle. (Figure 8)

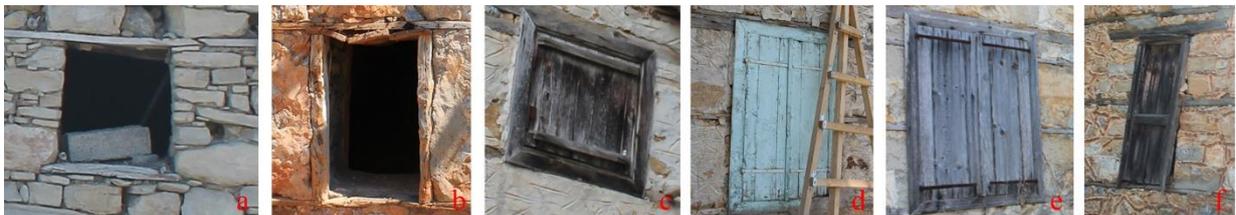
Figure 11. Types of ground floor windows of traditional houses in Alanya's rural region

The windows of the places such as the barn, warehouse, and haystack belonging to the ground floor were made in very small sizes with a width of 40-70 cm and a height of 50-90 cm and were not closed with any joinery except 5 villages (Figure 11a,b). The only difference in this situation is the residences located in the village of Türkteş (Figure 11c). Since there is also residential use on the ground floors in the village of Türkteş, window sizes are large as on the upper floors. In the windows of the lower floor, a ratio of 1/1.2 and 1/1.5 can be seen in this village (Figure 11d,e). One residence has a 1/2 window (Figure 11f). The windows have wooden joinery and iron fence, and the shutters are on the lower floors, typical of this village. In the windows with wooden sashes, the sashes are located on the outer surface of the windows and the opening directions are also outward. Only Başköy has sashes that open inward. The sashes used are both batten and paneled, the thickness of those with batten sashes was 2-3 cm, and those with paneled was 4-5 cm thick.

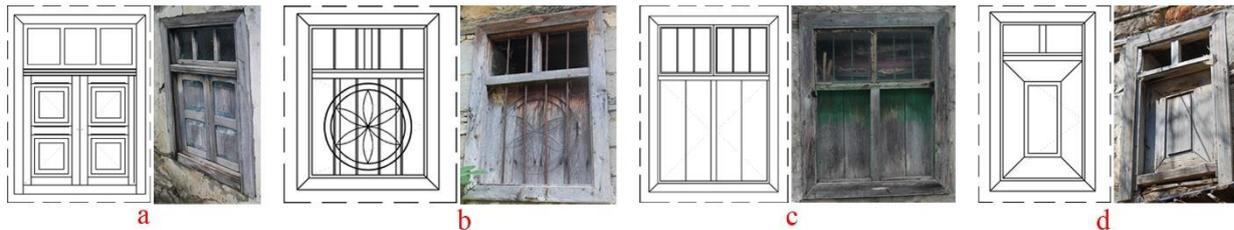
**Figure 14.** Gapless casement windows with skylight of traditional houses in Alanya's rural region

Another closed type window seen in the countryside is glassless windows with a skylight on them and these skylights consist of 2 (Figure 14b,c,d) and 3 sections (Figure 14a). This type of window can also have single (Figure 14b,d) and double sashes (Figure 14a,c), the sashes have 1 or 4 compartments, and can be both batten (Figure 14c) and paneled type (Figure 14a,b,d). Paneled ones have a transom (Figure 14a,d), which is decorated directly with carving (Figure 14b), and their thickness is 3-5 cm. Window proportions are 1/1, 1/1.2, or 1/1.5, but the skylight can either be glassless and empty (Figure 14b,c,d) or glazed (Figure 14a).

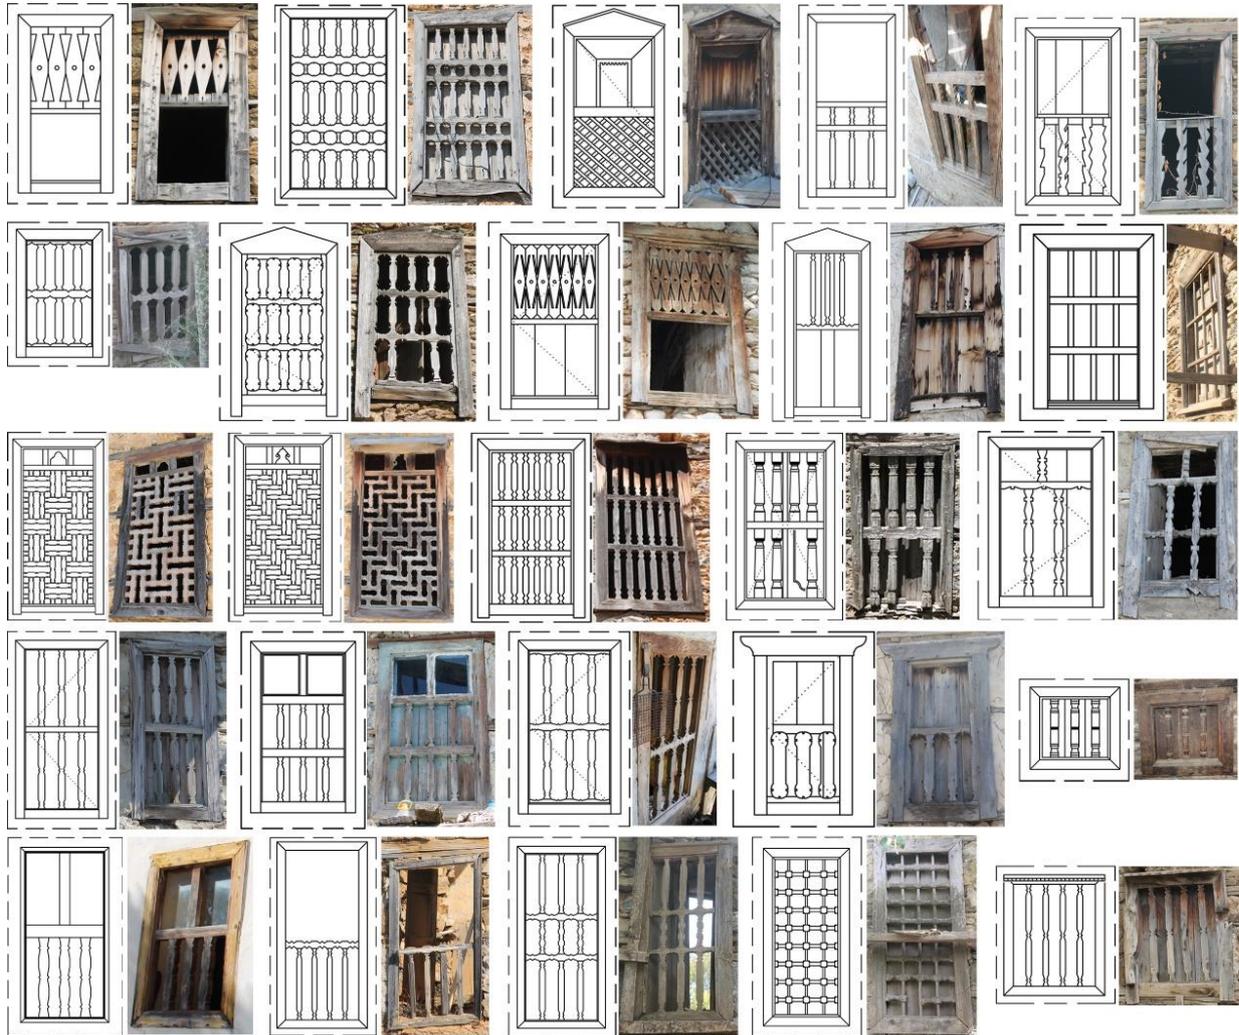
**Figure 17.** Types of wood railing of traditional houses in Alanya's rural region

Apart from these, the wooden fences that have a round cross-section and are not seen in the nearby areas in the surveys are also noteworthy. The fence thickness varies between 4-8 cm, but there are only 3

different types. One has 3 rows of bars, while the other has 4 rows of bars, and all the windows are single-winged and built without spaces (Figure 17).
